Navajo Abandoned Uranium Mine

Site Screen Report

Mine Name: Jim Hatattly
Mine IDs: 801, 802

Weston Solutions, Inc.

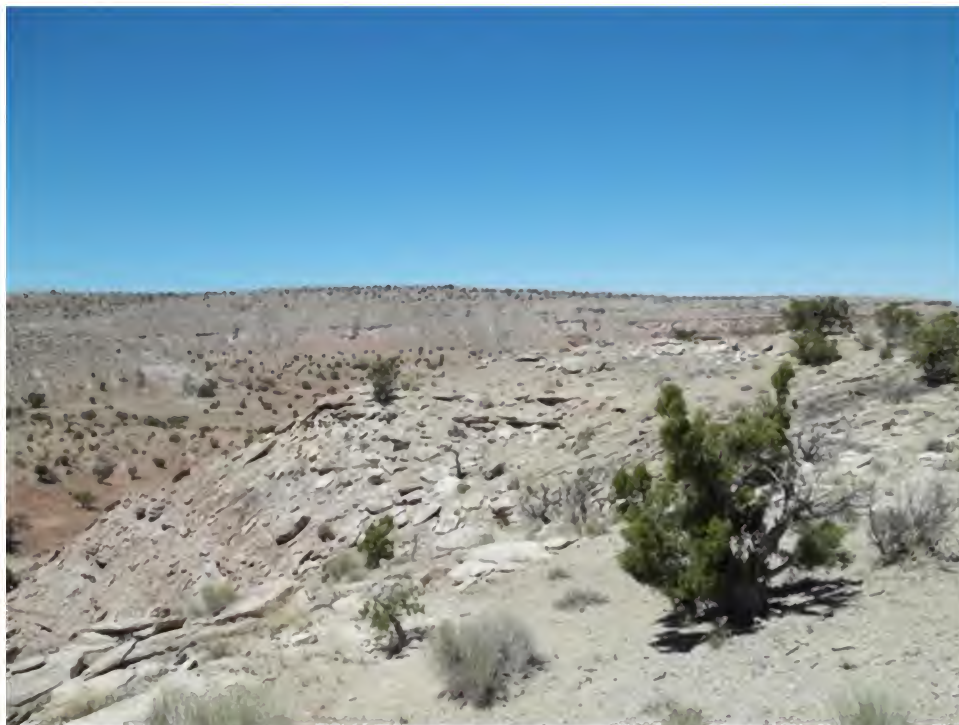
Photo 1: Mine Site #801; Cliff edge

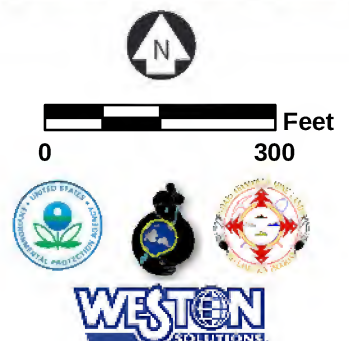
Figure 2 - Gamma Radiation Measurements
Jim Hatattly (801, 802)
Chilchinbito Chapter, Navajo Nation

Average background 8,857 cpm
